General Information

Property Information

Property Address 1234 School House Road
City Yourtown State US Zip 12345
Contact Name Ima Goodagent
Phone (111)-111-1111 Fax (111)-111-1111

Inspector Name Jim Johnson
Company Name Baltimore Home Specs LLC
Company Address 804 Dora Place
City Bell Air State MD Zip 21014
Phone (111)111-2111 Fax (111)111-2111
E-Mail inspections@inspector.com
File Number 22222
Amount Received \$350.00

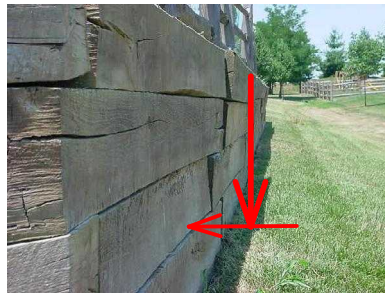
- 5. Balcony: Concrete
- 6. Porch: Concrete
- 7. Vegetation: Shrubs with some weeds
- 8. Retaining Walls: Railroad ties The wall is showing signs of movement, but appears to be stable at this time. A qualified contractor is recommended to evaluate and estimate repairs to maintain the wall.

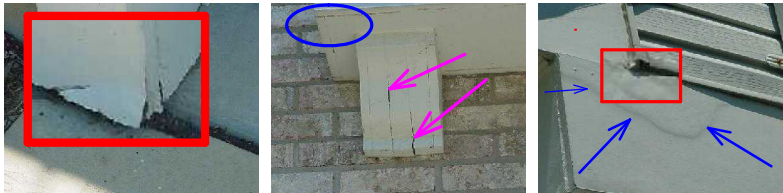
1. Water damage to trim wood at either side of garage door from moisture wicking into the finished particle board. The surface is starting to delaminate. Recommend repair/replacement of the trim boards and silicone seal wood that is in contact with concrete to prevent wicking.

2. The wood window boxes have water damage and will require repair/replacement. The wood has started to separate at the supports and at the corners of the window boxes.

3. The trim board at the southwest corner of the porch has water damage due to water penetration and will require repair/replacement of the wood. The trim board extends out creating a ledge allowing water to collect on the top edge of the board and cause the wood to rot.

Recommend estimate/repairs by a qualified contractor.

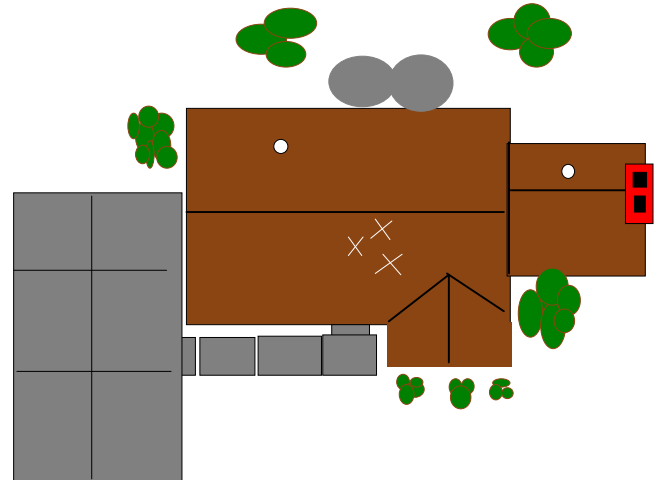
Main Roof Surface

- Method of Inspection: On the roof
- Unable to Inspect: 30% Height of the roof
- Material: Fiberglass shingle **Missing roof shingles from wind damage as marked "x" in diagram. Repairs are required.**
- Type: Gable

5. **Main Roof Surface Material:** Fiberglass shingle **Missing roof shingles from wind damage as marked "x" in diagram. Repairs are required.**

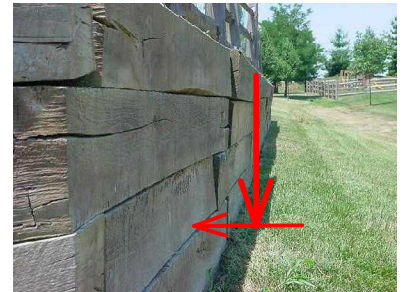
1. Vegetation: Shrubs with some weeds
2. Retaining Walls: Railroad ties The wall is showing signs of movement, but appears to be stable at this time. A qualified contractor is recommended to evaluate and estimate repairs to maintain the wall.
